Subject: PEFS LOP Valve Actuation Bypass

Product: PEFS F3/F3N/C6 LOP systems

Parts: 28059 LOP Valve Actuation Bypass

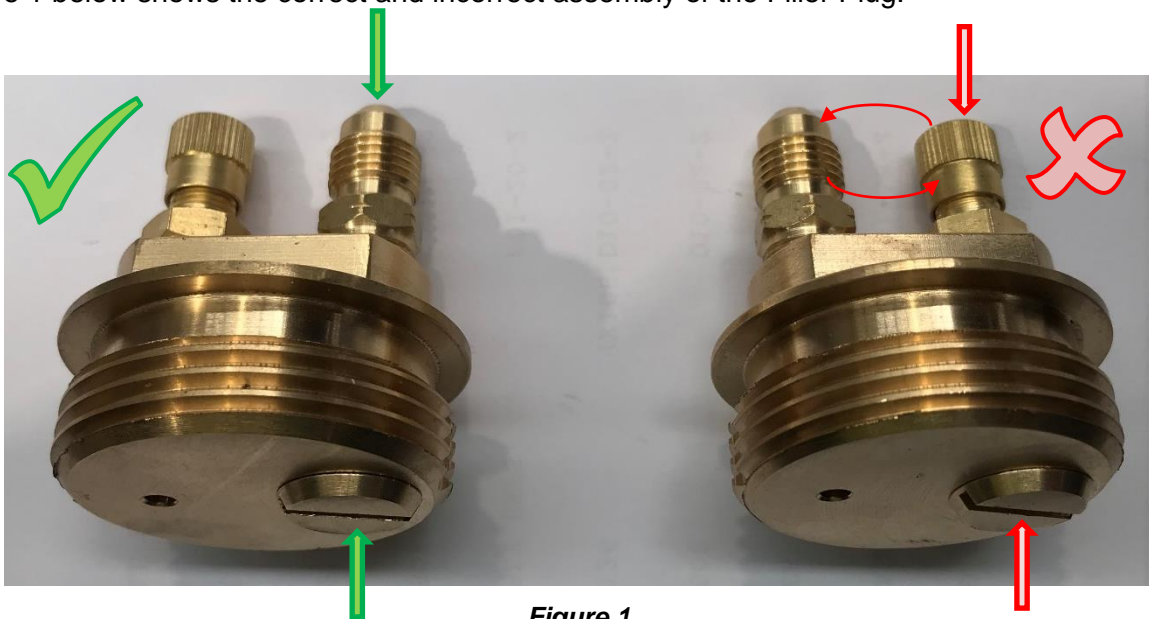
There have been a couple of reports where the LOP Valve Actuation Bypass Filler Plug has been found incorrectly assembled. The incorrectly assembled Filler Plug will allow the pressure in the cylinder to release through to the actuation lines when the system is actuated and will prevent the LOP valve from opening.

Figure 1 below shows the correct and incorrect assembly of the Filler Plug.

Prior to installation visually check the orientation of the Schrader valve and connection adaptor as per Figure 1 above. If the assembly is incorrect and/or without a punch mark, carry out the rectification as needed.

- Unscrewing and re-assembling the Schrader valve and the connection adaptor in the correct configuration as per Figure 1 above.
- Use Loctite 577 on the threads.
- Notify Chubb QA at gerrard.prakash@chubb.com.au

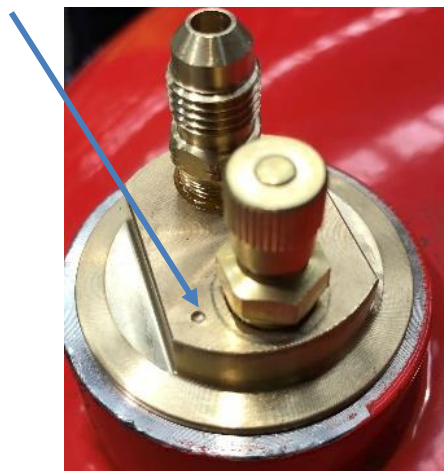
Figure 2

Chubb has implemented additional quality control inspections of production stock to ensure the Filler Plug is correctly assembled prior to release. From September 2021 all Bypass Kits will be supplied with a Filler Plugs that can be visually identified by the punch mark near the Schrader Valve as shown below in Figure 2.

Once the Filler Plug has been verified that it is assembled correctly it should then have a punch mark applied to the Filler Plug near the Schrader Valve as shown in Figure 2. This is to identify that the Filler Plug has been checked and is correctly assembled on all future scheduled maintenance.

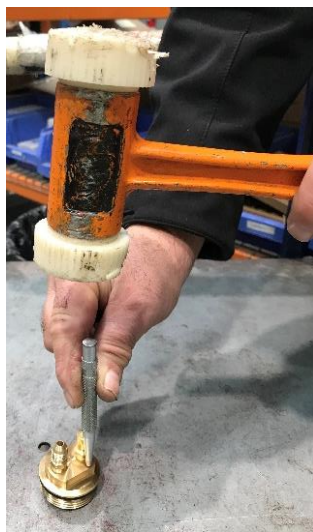
Figure 3

Note: As the material is brass, it only requires a light stamp using a punch and soft mallet. This can be carried out on a solid bench prior to installation or can be carried out in place on an installed cylinder.
